### Fletcher Trace Parkway Headwall Replacement

Two storm sewer outfall structures on Fletcher Trace Parkway were deteriorating and structurally unstable. The structures support three to four storm sewer pipes each which convey a large amount of stormwater from upstream neighborhoods to Fletcher Creek. The headwall located on Fletcher Trace Parkway and Eton Cove was replaced in 2010. The headwall located on Fletcher Trace Parkway and Slezenger Drive was replaced in 2011.

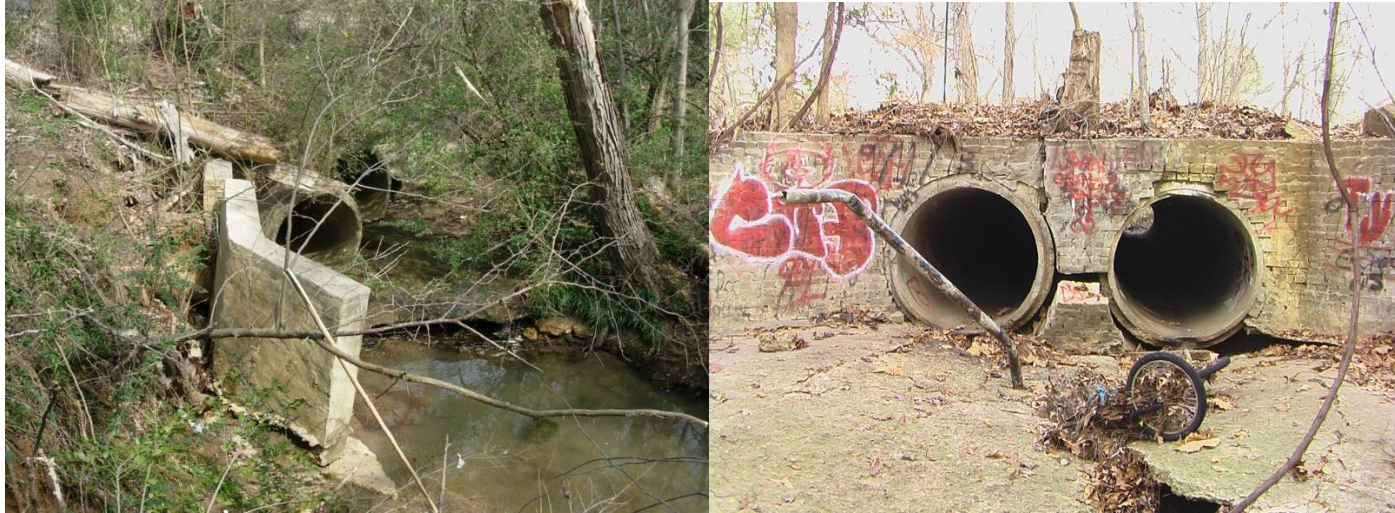
Fletcher Creek headwalls before repairs:

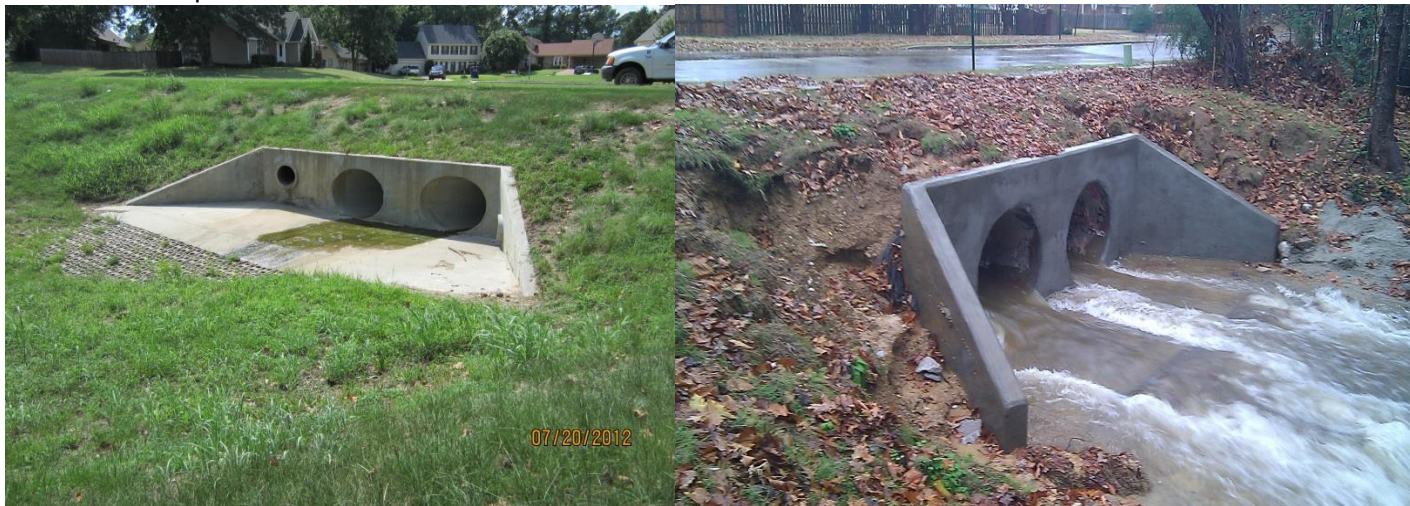
Fletcher Creek headwalls after repairs:
